Re: Hull WPCF Capacity, Management, Operation and Maintenance ("CMOM") Corrective Action Plan  
Town of Hull, MA Administrative Order on Consent, Docket No. CWA-01-AO-16-09

# CMOM CORRECTIVE ACTION PLAN

Hull POTW

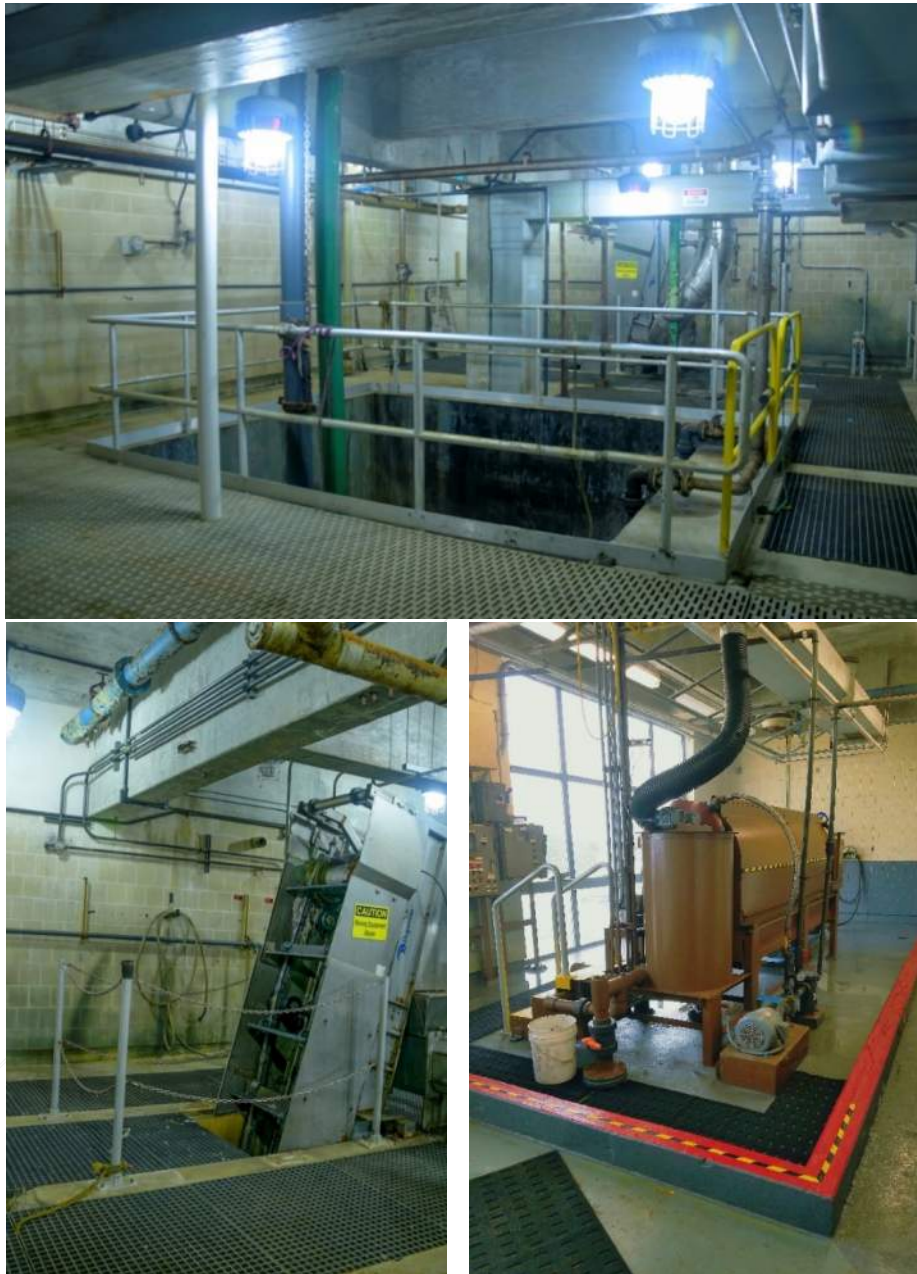
**Figure 3-1: Photos of Completed Equipment Work at WPCF, July 2017**

Top: Headworks with safety railing improvements, Bottom Left: Mechanical Bar Screen in operation, Bottom Right: Rotary Drum Thickener post-cleaning and corrective maintenance improvements.
